Chapter 6: Structural System

This chapter describes signs of structural distress, deterioration and damage by material type: masonry (the most difficult to assess), wood, iron, steel and concrete.

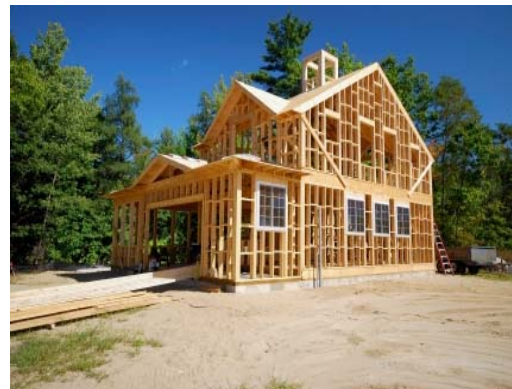
- Wood frame and masonry buildings with more than one story above grade where the story at grade is a large unobstructed open space, such as a garage. Such buildings may be vulnerable to collapse of the story at grade.

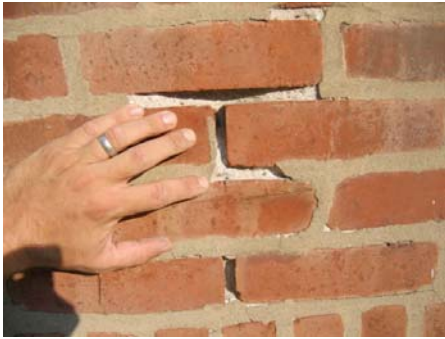
Mortar deterioration. The age of the building may be a good clue in evaluating its mortar problems. The two important qualities of mortar are its ability to bond to masonry and its internal strength. Older mortar (or mortar of any age that uses hydrated lime) will be softer and may require pointing, but otherwise may be responsible for a sound wall.

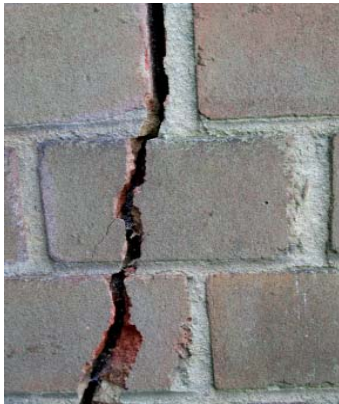
Uneven settlement.

Uneven (or differential) settlement can be a major structural problem in small residential buildings. Serious settlement problems are relatively uncommon. Many signs of masonry distress are incorrectly diagnosed

Indications of differential settlement are vertical distortion or cracking of masonry walls, warped interior and exterior openings, sloped floors, and sticking doors and windows.

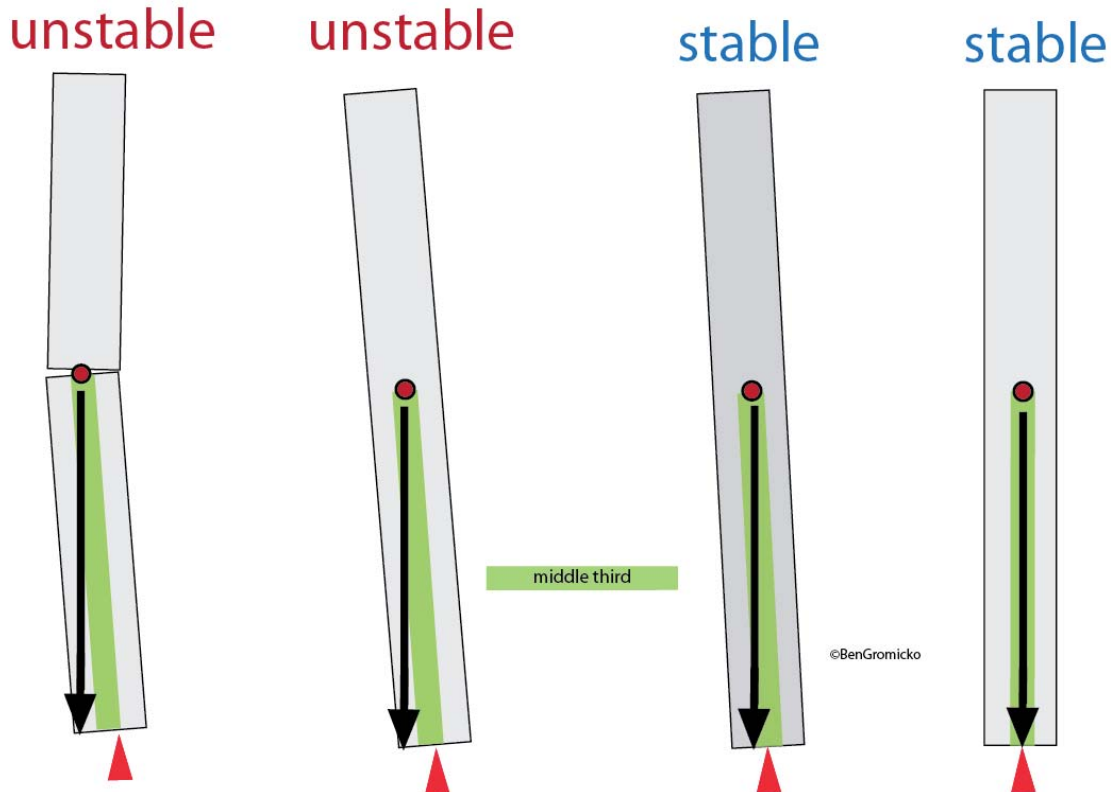
- Settlement or rotation of the pier footing can cause a lowering or tilting of the pier and subsequent loss of bearing capacity. Wood frame structures adjust to this condition by flexing and redistributing their loads or by sagging (see Section 6.7). Masonry walls located over settled piers will crack.

- Frost heaving of the footing or pier, a condition caused by the lack of an adequate footing or one of insufficient depth can raise or tilt a pier. This could show up as movement similar to that caused by settlement or rotation of the footing. Such a condition is most common under porches and decks.

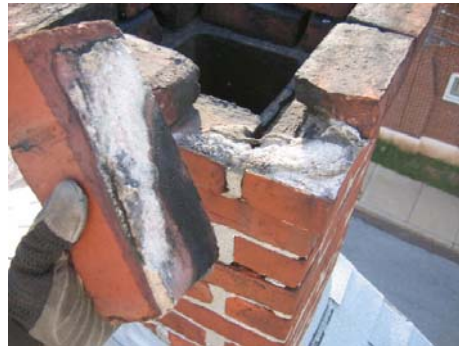
- An inadequate foundation can cause differential settlement of the chimney, but the foundation is underground and not readily visible. If the chimney is part of an exterior wall, it will tend to lean away from the wall and crack where it is joined to other masonry. In some cases, the chimney can be tied to the building.

- A chimney sweep can monitor the chimney structure for you. Masonry at the top of the chimney stack can deteriorate due to a deteriorated cap that allows water into the masonry below and exposes it to freeze-thaw cycles. This cap is often made of a tapered layer of mortar, called a cement wash, which cracks and breaks after several years. If the cap is mortar and the chimney has a

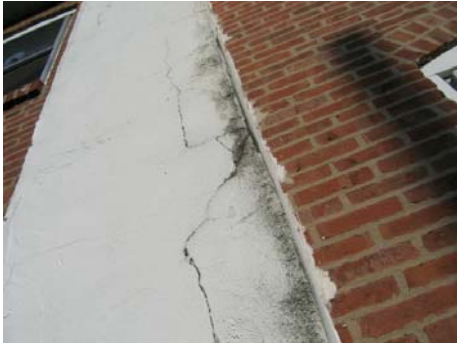
- The chimney could lean where it projects above the roof due to deteriorated mortar joints caused either by wind-induced swaying of the chimney or by sulfate attack from flue gases and particulates within the chimney when the chimney is not protected by a tight flue liner. Deteriorated mortar joints should be pointed, and unstable chimneys or those with a noticeable lean should be dismantled and rebuilt.

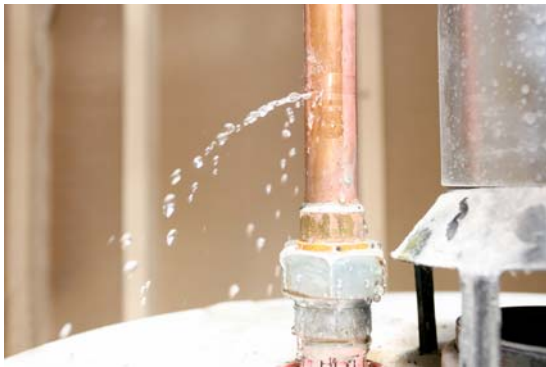
Water meter. The water meter is normally the property of the municipal water company and may be located near the street, adjacent to the house, or within the house. If the water meter is located inside the house, look for two shutoff valves, one on the street side and one on the house side of the meter.

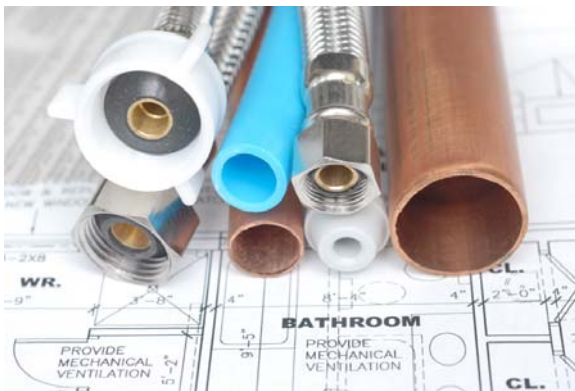
All piping, regardless of composition, should be monitored for wet spots, discoloration, pitting, mineral deposits and leaking or deteriorated fittings.

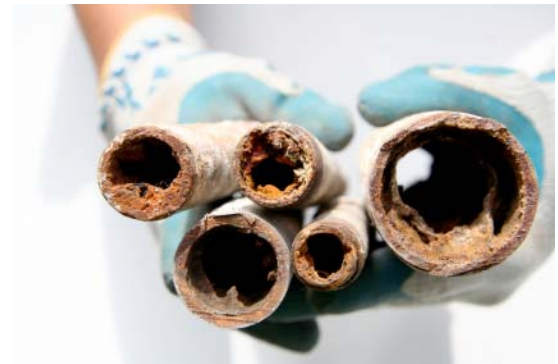
Galvanized steel piping is subject to rusting and accumulating more mineral deposits than most other piping materials. Rusted fittings and rust-colored water, particularly from hot water lines, are signs of advanced deterioration. Low rates of flow and low water pressure are likely to be caused by galvanized steel piping clogged with rust and mineral deposits. If galvanized steel piping is found, consider replacing it.

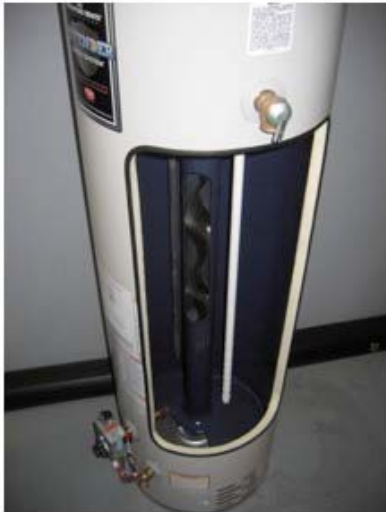
Tank water heaters consist of a glass-lined or vitreous enamel-coated steel tank covered by an

insulated metal jacket. They are gas-fired, oil-fired or electrically heated.

- Gas-fired tank water heaters have an average life expectancy of about 6 to 12 years and a fairly high recovery rate.
- Oil-fired heaters have an average life similar to that of gas-fired heaters. Their recovery rate is also high.
- Electric water heaters have an estimated service life of 5 to 10 years. They have a low recovery rate and thus require a larger storage tank.

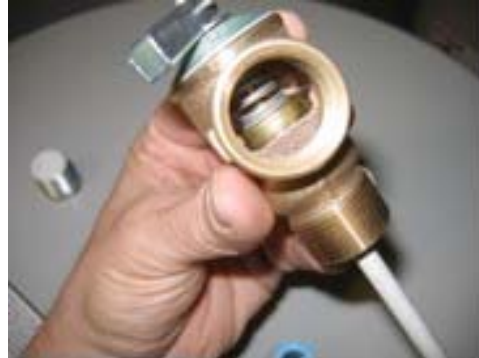
Check the temperature/pressure relief valve (sometimes on the top or on the side of the tank), and for a discharge pipe that extends from the valve to a few inches from the floor, a floor drain or the building exterior, depending on local code requirements. This pipe should never be dripping or leaking water.

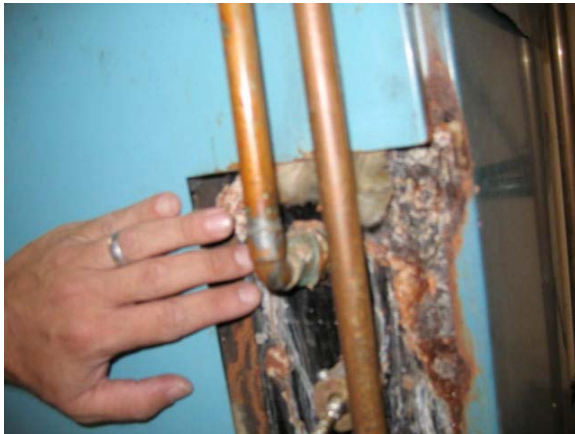
Tankless domestic coil water heaters consist of small diameter pipes coiled inside of or in a separate casing adjacent to a hot water boiler. They are designed for a rate of water flow, usually three to four gallons per minute. The recovery rate of a domestic coil water heater is instantaneous for low demand and will vary for high demand. The life expectancy of a domestic coil water heater is limited only by the deterioration of its coils and by the service life of the boiler to which it is attached.

Monitor tankless coil water heaters by checking its performance (ability to produce hot water on demand) and by checking the area where the coil is attached to the boiler. Over time water

may start to leak from the gasket area or the bolts at the front mounting plate where the tankless coil is located at the boiler.

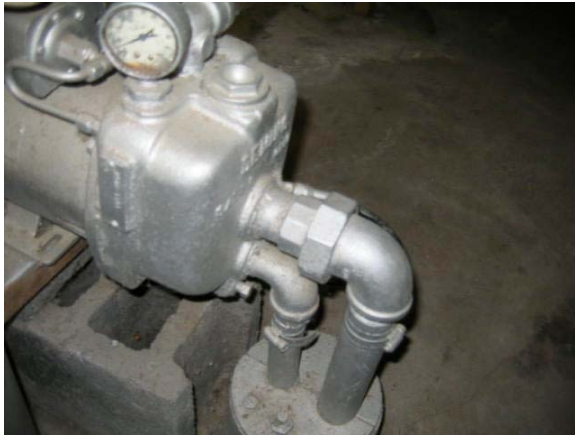
Pumps. Two kinds of deep well pumps are in common use: the jet pump and the submersible pump.

A jet pump is mounted above the well casing, and two pipes should extend into it; if there is only one pipe leading into the casing, the well is less than 25 feet deep and may have inherent performance problems. Submersible pumps are located at the bottom of the well casing (submerged) and a single discharge pipe and an electrical supply cable extend from the top of the casing. The life expectancy of deep well pumps is 10 years or longer, depending on the type. Submersible pumps are usually the most long lasting and trouble free.

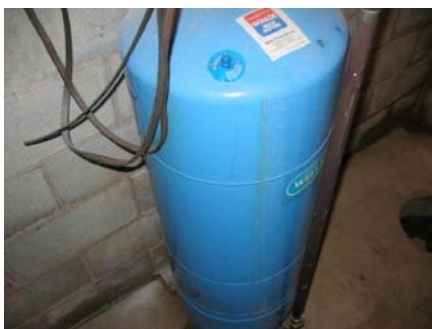
Pressure tank. A tank under low air pressure (a hydropneumatic tank) should be located in either the well house or the building's basement. This

tank regulates water pressure and flow.
